# TECHNICAL SERVICE BULLETIN

**BULLETIN NUMBER: D111/D142 – 009 REISSUE ★**

**LANIER – MP C3002/MP C3502**  
**RICOH – AFICIO MP C3002/C3502**  
**SAVIN – MP C3002/MP C3502**

**SUBJECT: SC544, SC554, SC564, OR SC574 OCCURS**

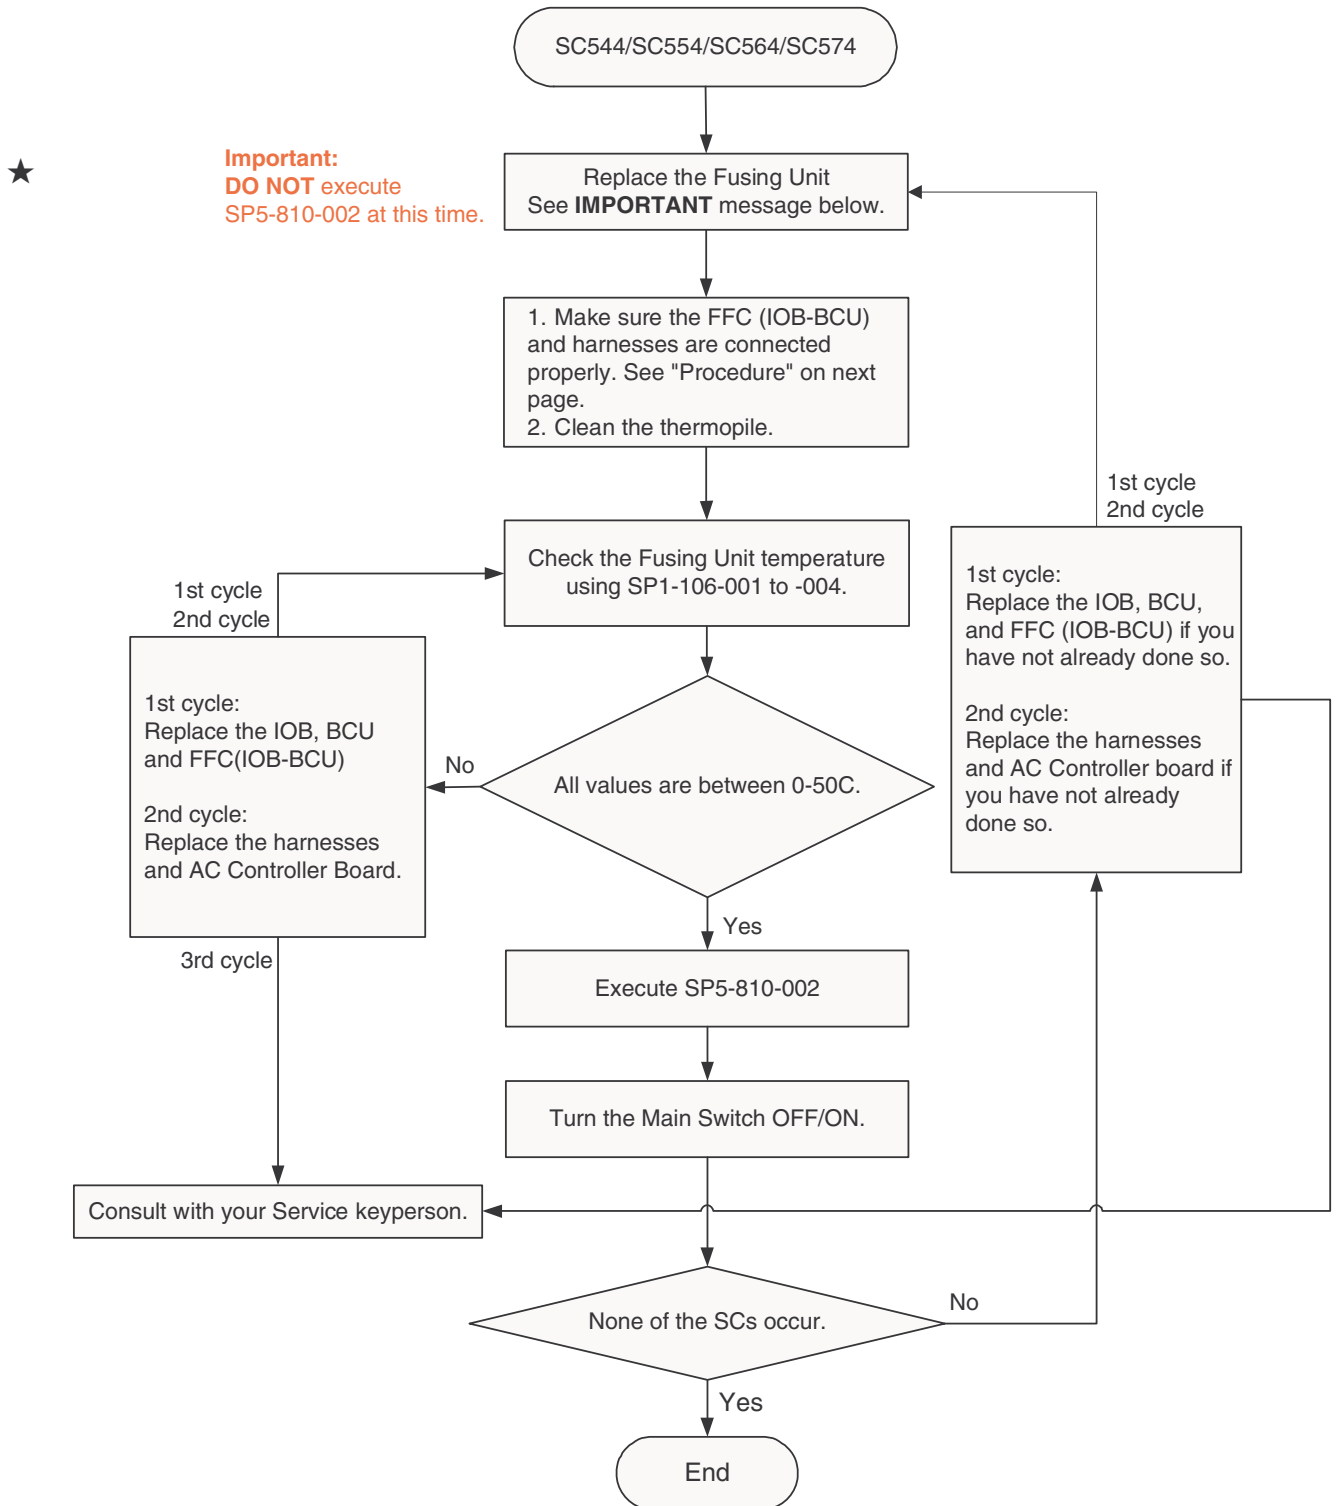
**FLOWCHART:**

An SC544, SC554, SC564, or SC574 occurs.

Several factors may cause this symptom.  
See the [Flowchart](#) in the “**Solution**” section below.

Follow the directions in the [Flowchart](#) on page 2 of this TSB.

★ **IMPORTANT:** When replacing the Fuser Unit, you **must** use a new Fuser Unit service part. Fusing Units removed from a working machine will **not** allow the machine to reset the SC Code.

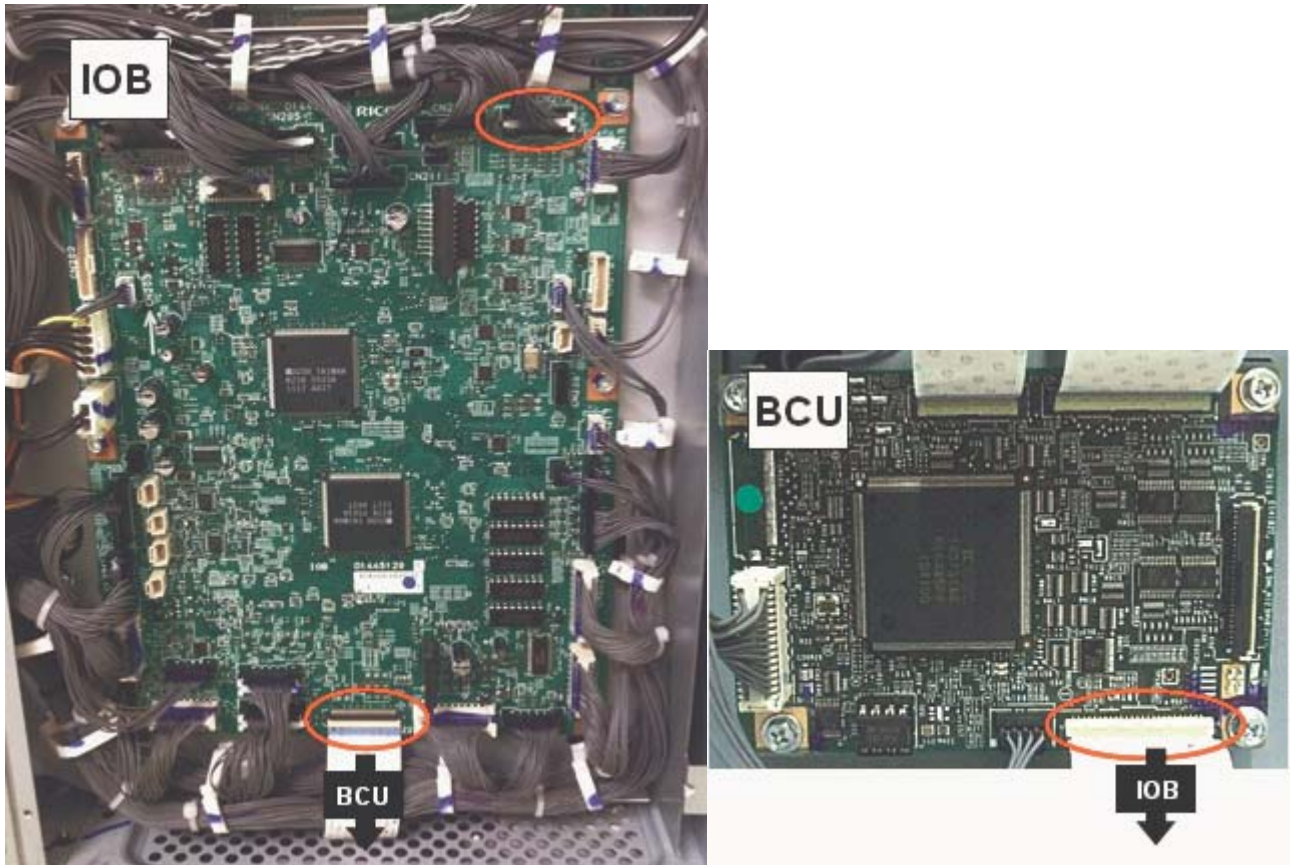
1. Make sure that the harness and FFC circled in red below are connected properly (see details below). If they are not, reconnect them.

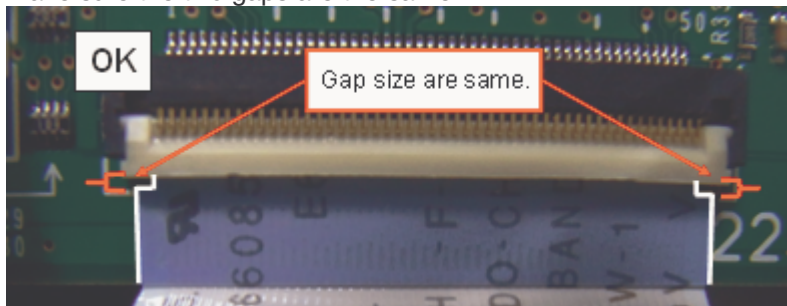
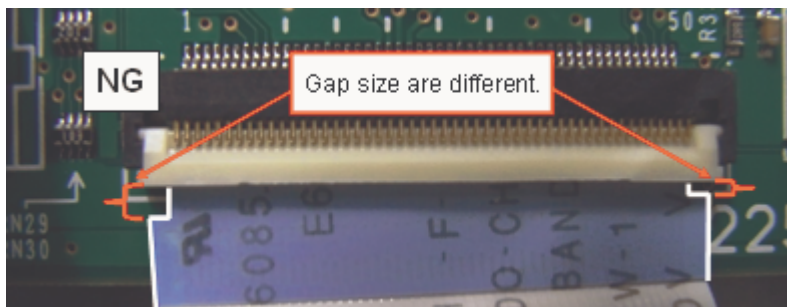
- a) Make sure the two gaps are the same.

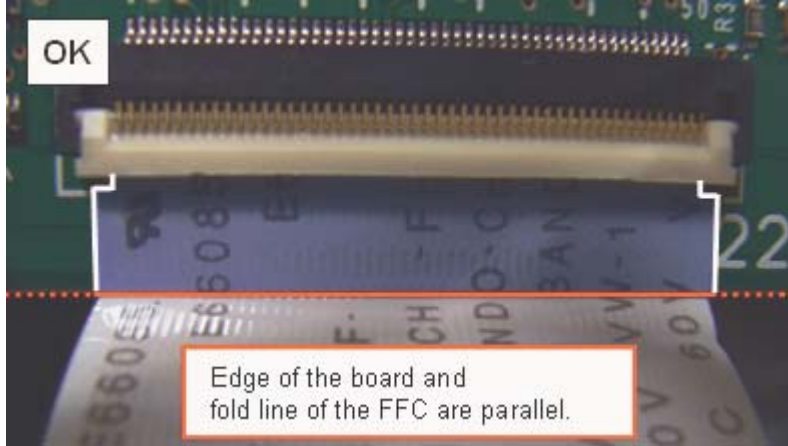
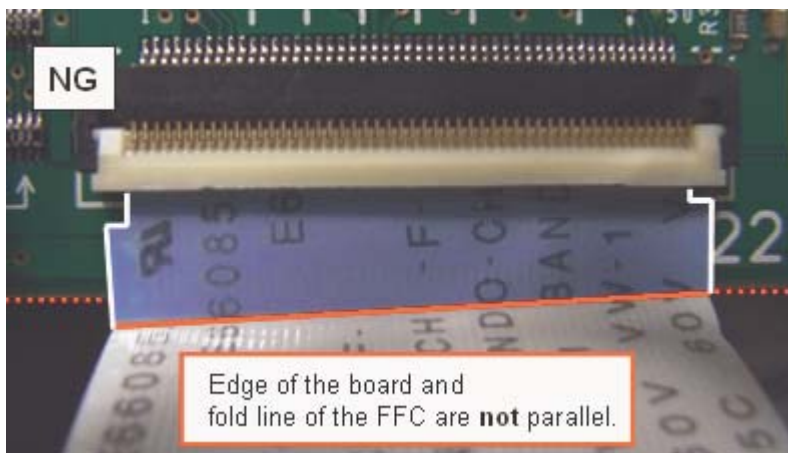
- b) Make sure the edged of the IOB side connector and fold line of the FFC are **parallel**.

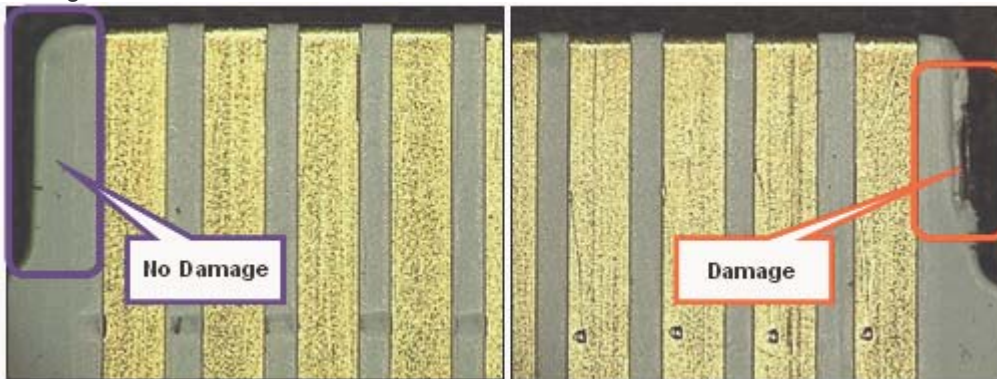
- c) Check for any damage to the FFC.  
Use a loupe to check for any damage to the edges of the FFC. If you find any, replace the FFC. If there is no damage, follow the instructions in the flowchart.

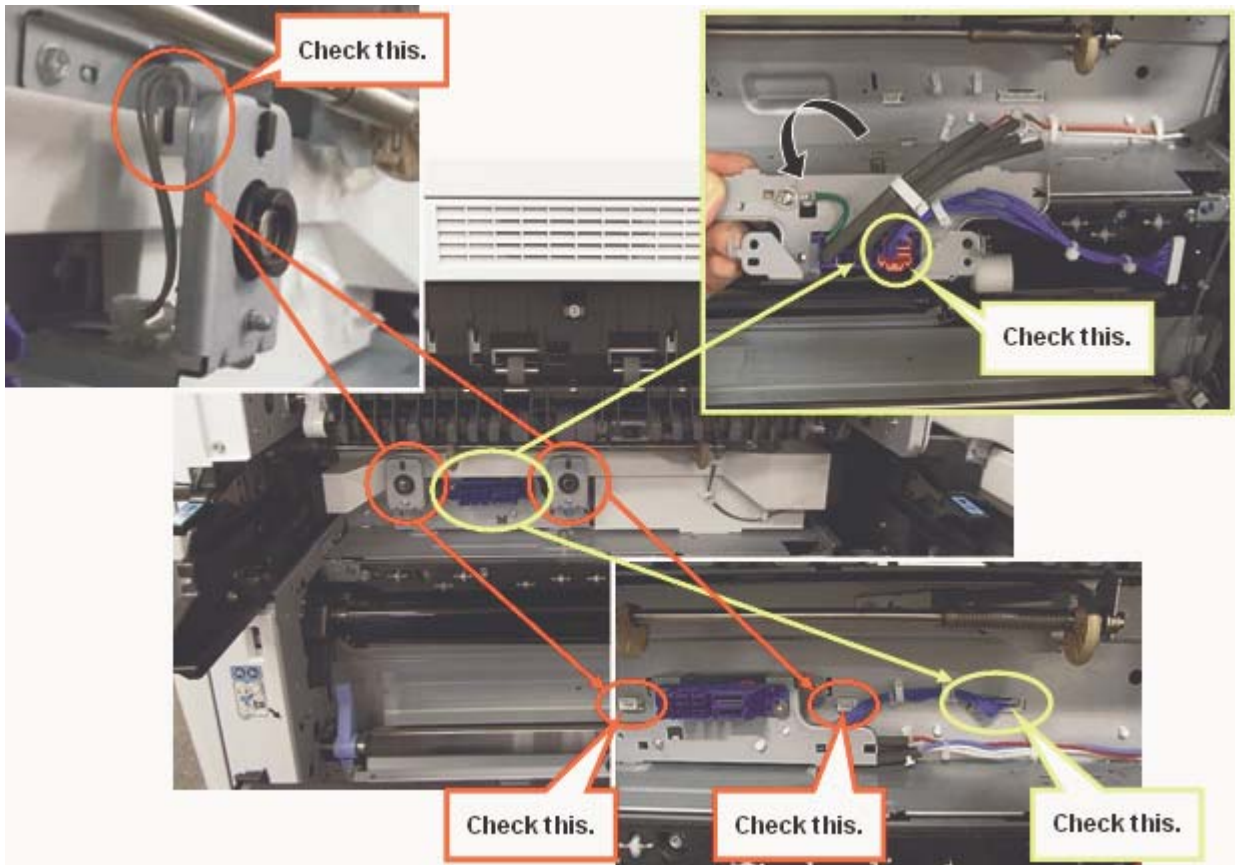
- ★
2. Make sure that the harnesses marked in the photos below (“Check this”) are connected properly. If they are not, reconnect them.
