**A250/B001**  
**SERVICE MANUAL**

000846MIU

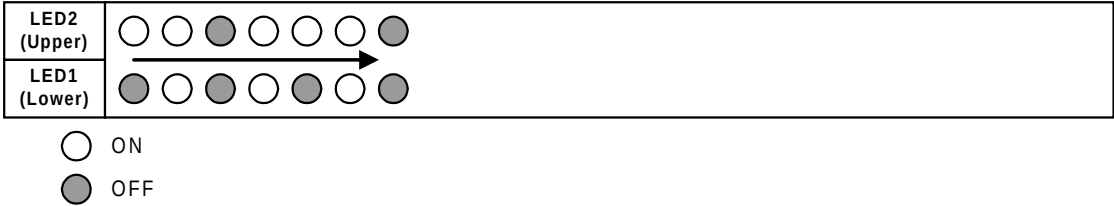
SDRAM Error

Turn off the machine and turn it back on. If the controller detects the same error, replace the controller.
