Pro C5100/C5110 series

Operating Instructions

Troubleshooting: TCRU/ORU

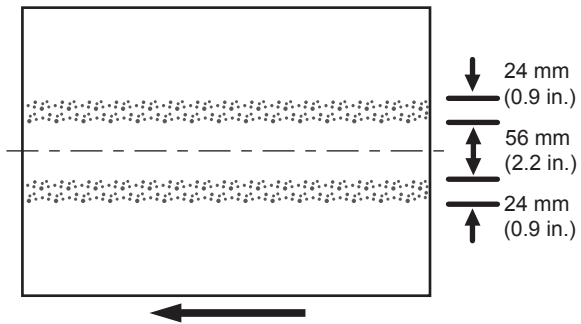
CNT006

Two 24-mm wide streaks parallel to the paper feed direction appear.

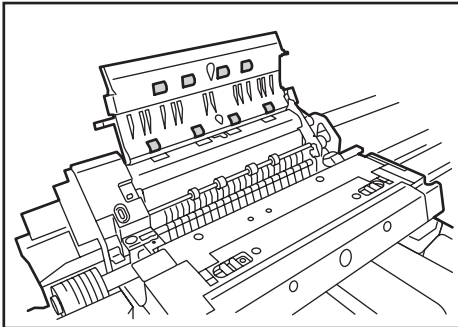
4. Turn the rollers to clean them using a slightly damp cloth.

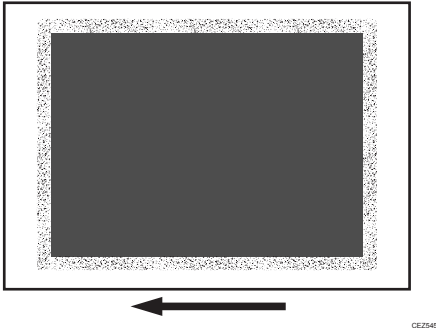
Toner is scattered around a solid-fill print.

This may occur if printed at low temperature or humidity.

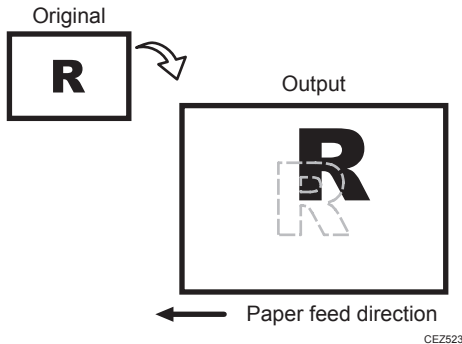
The Image Is Positioned Incorrectly

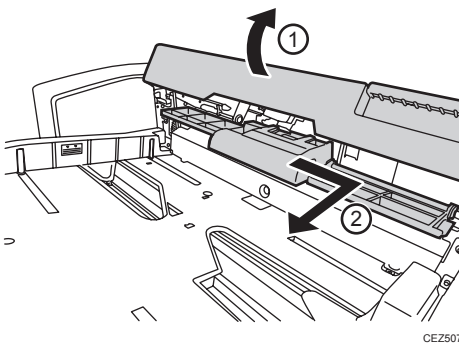
1. Remove the loaded paper.
2. Open the upper cover, and then detach the paper feed unit.

Pull it out slightly, release the metal shaft, and then detach it.

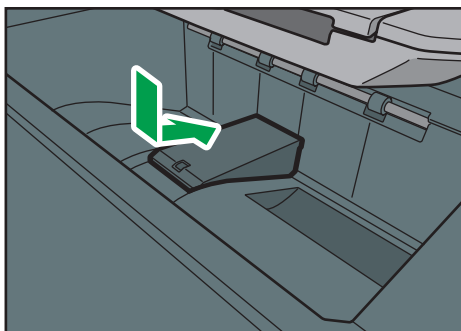
Use the Z-fold support tray for multi-folding unit.

This will reduce the angle of stacked bundles and prevent bundles flipping over as they are delivered.
